# Monopole Base Weld Toe Cracks and Why They May Collapse Your Tower

By Brian R. Reese, P.E., CWI, and David W. Hawkins, P.E.

Crack identification and a proposed severity classification system hold promise for helping owners maintain their towers in the face of aging and wear that can lead to cracks that threaten structural integrity.

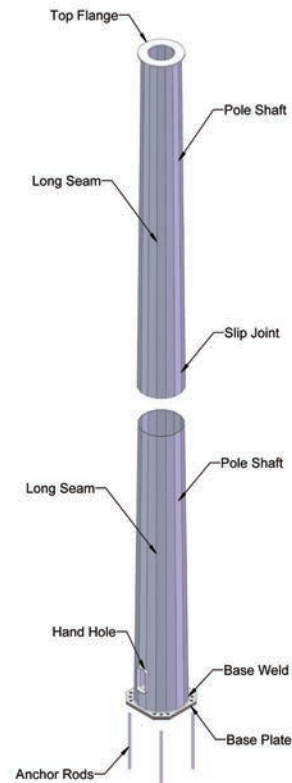
**Figure 2.** An unmitigated failure of the welded connection between the base plate and the pole shaft almost always causes a pole to collapse.

An anchor-based pole has a welded base plate that connects the structure via the anchor rods to the foundation (see Figure 2). The base connection is facilitated by shop-welding the steel base plate to the bottom of the pole shaft during fabrication at the original manufacturer's facility. The weld between the base plate, and the pole shaft is the only structural connection between those members. It is nonredundant, and therefore the structural adequacy and integrity of this welded connection is crucial to the structure. If an unmitigated failure were to occur at this joint, in almost all cases the pole would collapse.

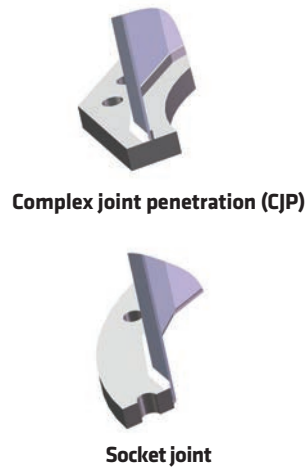
**Figure 3.** Typical pole base connection weld details include complete joint penetration (CJP) groove weld and socket-style (double-fillet weld) connections.

The connection detail of the pole shaft to the base plate can vary depending on the type of pole or the manufacturer. Typical pole base connection weld details include complete joint penetration (CJP) groove weld and socket-style (double-fillet weld) connections (see Figure 3). The CJP connection base plate butts against the pole shaft and consists of a

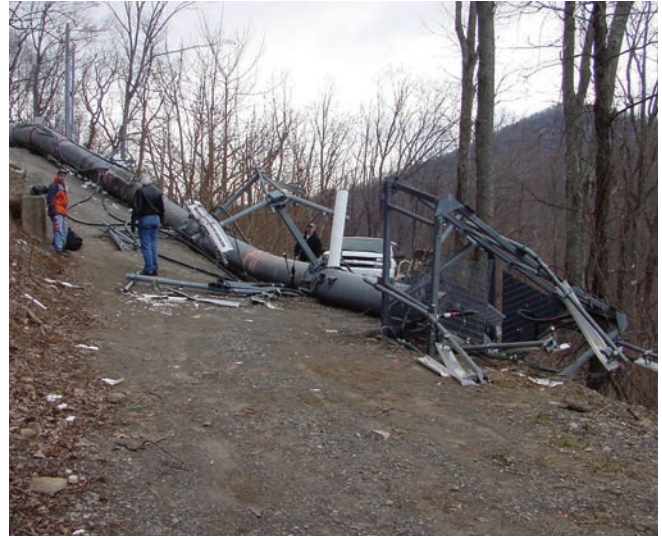
**Figure 4.** Although poles collapse infrequently, when they do, it often makes the news.

Pole collapses, although they generally occur quite infrequently, have made news in recent years because of structure failures in both the communications and the sports lighting industries (see Figure 4). In the sports lighting industry, the first-ever recall of poles was issued by the U.S. Consumer Product Safety Commission in 2010. The proximity of these structures to areas where people live, work and gather raises a significant potential for property damage, injury and possibly even loss of life.

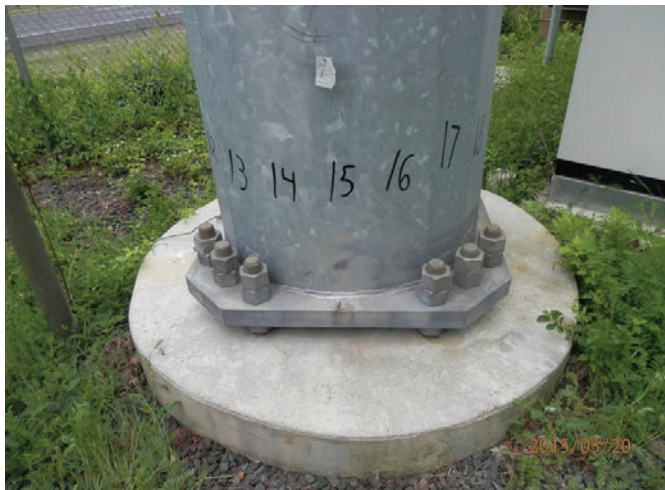
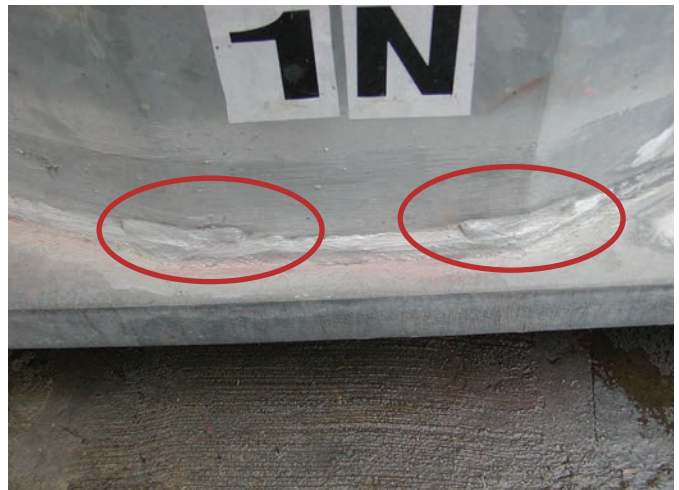
**Figure 5.** Toe cracks in polygonal poles typically first occur near the vertices (bend-lines or points of the multisided shaft) because this area generally has a higher stress concentration.

Most pole manufacturers inspect for toe cracks after the galvanizing process as a normal part of their quality assurance program. In instances where preventive field inspections have been performed on the base plate weld connection while in service, cracks have been found in the pole shaft at the upper toe above the base plate weld. This has occurred on multi-sided (polygonal) and round poles in both complete joint penetration groove weld and socket base plate connections. Toe cracks in polygonal poles typically first occur near the vertices (bend-lines or points of the multisided shaft) because this area generally has a higher stress concentration (see Figure 5).

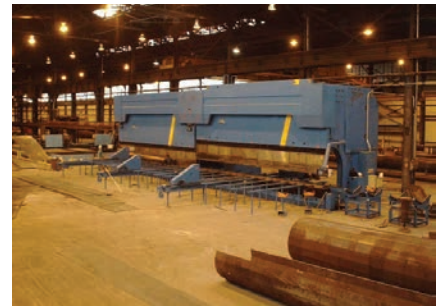
**Figure 6.** In the manufacturing (cold bending) of a polygonal section, tubular pole sections are fabricated by press-forming high-strength steel plate using a press brake.

**Fabrication.** In the manufacturing (cold bending) of a polygonal section, tubular pole sections are fabricated by cold press-forming, high-strength steel plate using a press brake (see Figure 6). Embrittlement of the steel can occur at the bend points because of the cold working of the material (i.e., strain hardening) resulting in high residual stresses.

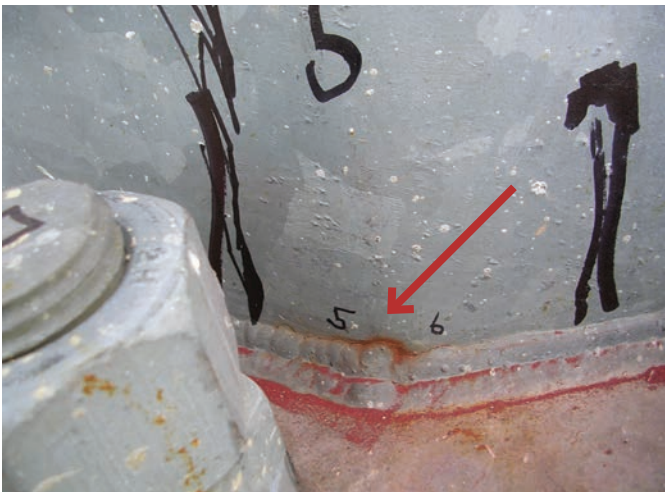
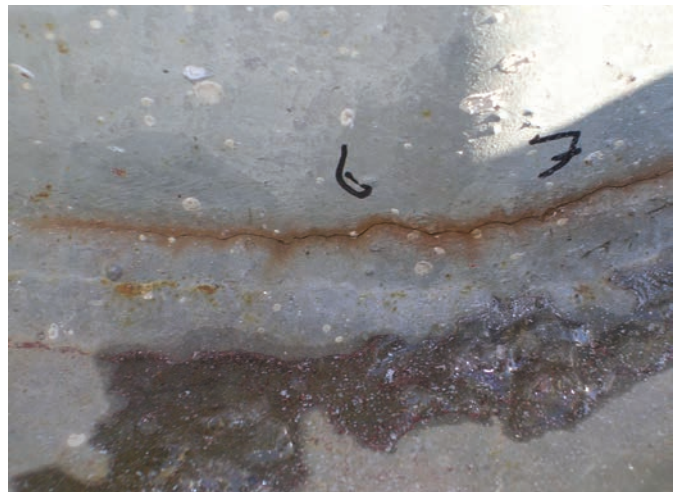
**Figure 7.** Toe cracks at upper toe of weld in pole shaft at polygonal bend line (visible rust).

1. In the most severe cases, “wandering” along the upper toe of the weld on the press bend line between two flats on a multi-sided pole is visible with the naked eye (see Figure 7).
2. Cracks may be identified with

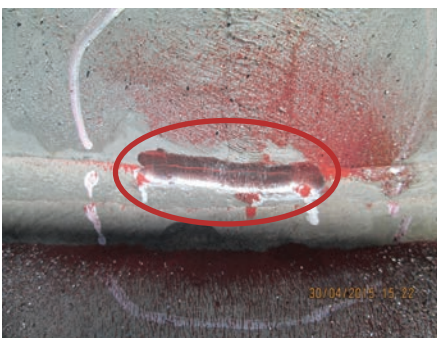
**Figure 8.** A minor toe crack is visible via MT powder after light grinding.

magnetic particle (MT) testing at the surface or near the surface that are not visible to the naked eye (see Figures 8, 9 and 10).

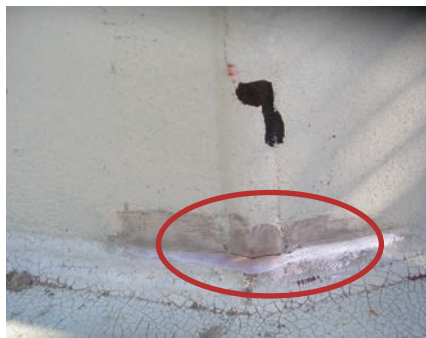
**Figure 9.** A toe crack is still visible via MT exam after grinding.

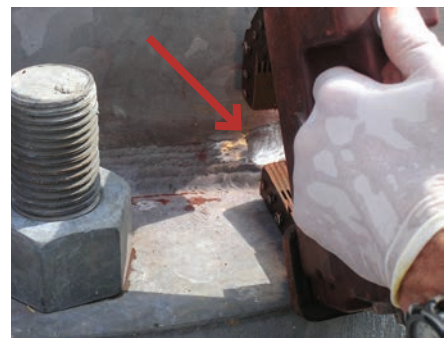
**Figure 10.** An MT exam showing indication (crack) at upper toe.

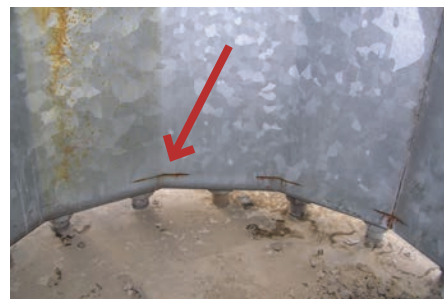
Figure 11. Socket-style pole base through-wall toe cracking viewed from the inside of the pole (visible rust).
