Planning Advisory Notice

Welding Discontinuities and Defects

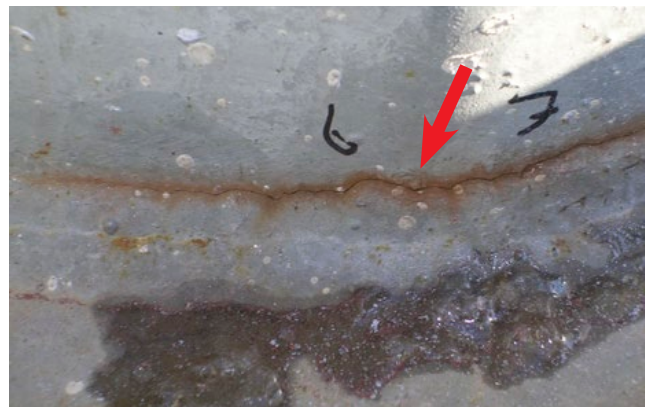
There are numerous types of cracks: longitudinal, transverse, crater, throat, toe, root, under bead, heat-affected zone. Per AWS D1.1 Structural Welding Code, no crack is allowed to remain in service after identification – "any crack shall be unacceptable, regardless of size or location." Cracks are very detrimental to the performance of a structure, can accelerate the negative effects of fatigue, and can cause the failure of the structure under load. A crack at the base of a monopole can cause catastrophic failure of the structure.

Monopole Base Plate Weld Upper Toe Crack

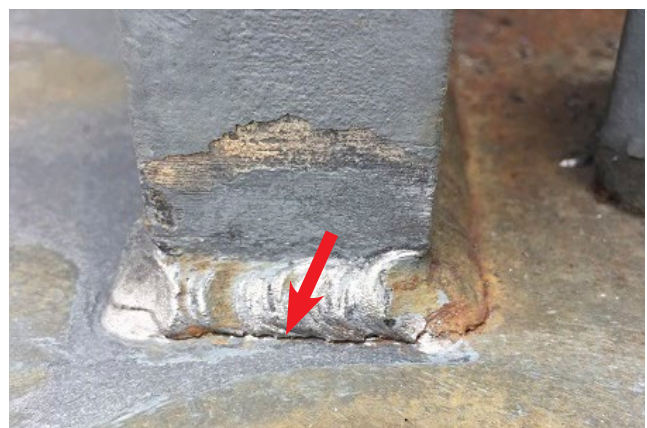
Base Plate Stiffener Weld Lower Toe Crack

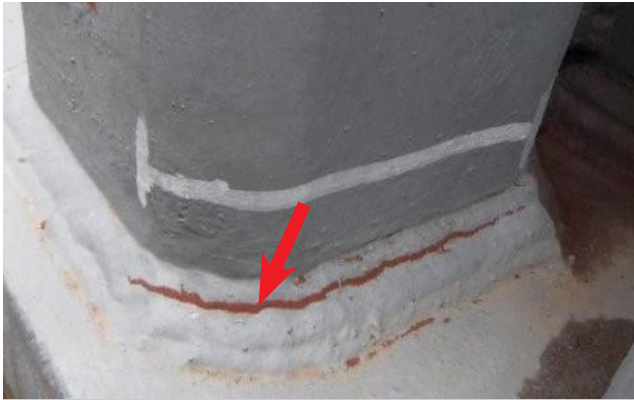
Anchor Rod Bracket Longitudinal Crack (Shown in Red)

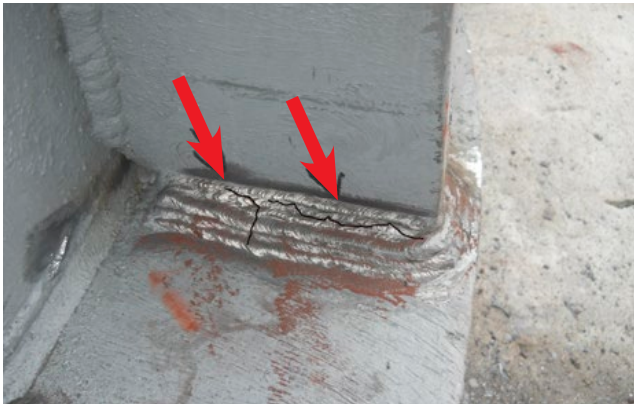
Stiffener Longitudinal & Transverse Cracks (in Black)

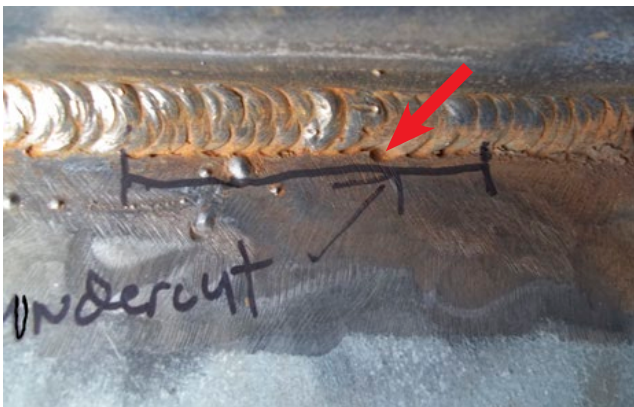
Monopole Modification Weld Undercut

Undercut is defined as “a groove melted into the base metal adjacent to the weld toe or weld root and left unfilled by weld metal.” Undercut can greatly reduce the fatigue-resistance of a welded connection. Undercut is generally associated with either improper welding techniques or excessive welding currents, or both. AWS D1.1 Table 6.1 allows some undercut as acceptable depending on whether the connection is a statically loaded non-tubular connection or a cyclically loaded (fatigue sensitive) non-tubular connection.

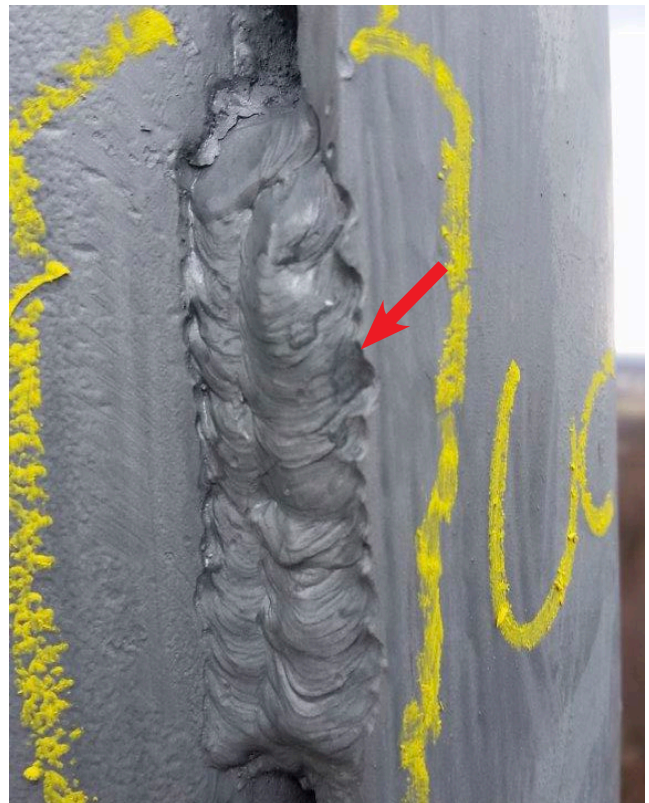
Tower Leg Split Pipe Stitch Weld Undercut

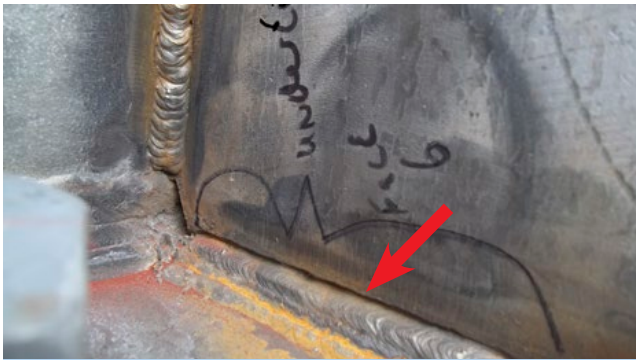
Underfill is a groove weld condition in which the weld face or root surface is below the adjacent surface of the base metal. Basically, the joint has not been completely filled with weld metal.

Monopole Base Plate Stiffener Underfill

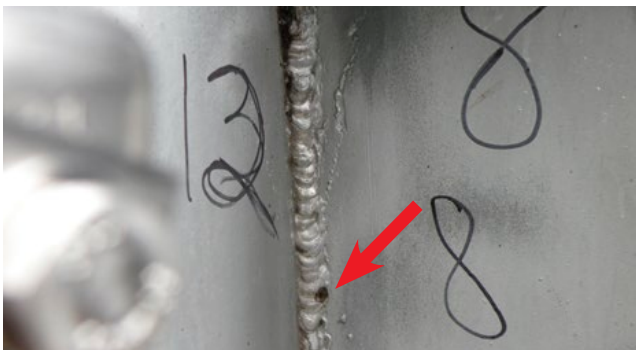
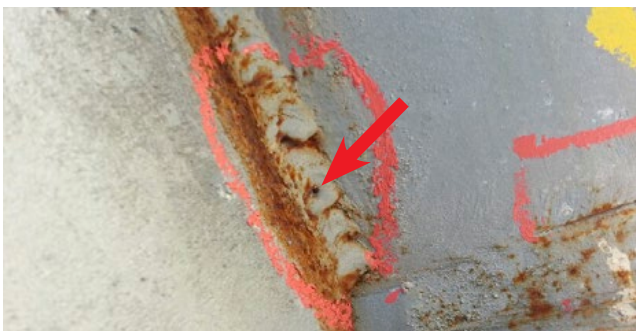
Porosity is a cavity type discontinuity formed by gas entrapment during solidification. The discontinuity formed is generally spherical and may be elongated. Porosity is caused by contamination during welding. There are various types of porosity including: scattered porosity, elongated porosity, aligned or linear porosity, and piping or wormhole porosity. Similar to undercut, AWS D1.1 allows some porosity in Table 6.1 as acceptable depending on whether the connection is a statically loaded non-tubular connection or a cyclically loaded (fatigue sensitive) non-tubular connection.

Examples of Porosity in Monopole Modification Welding

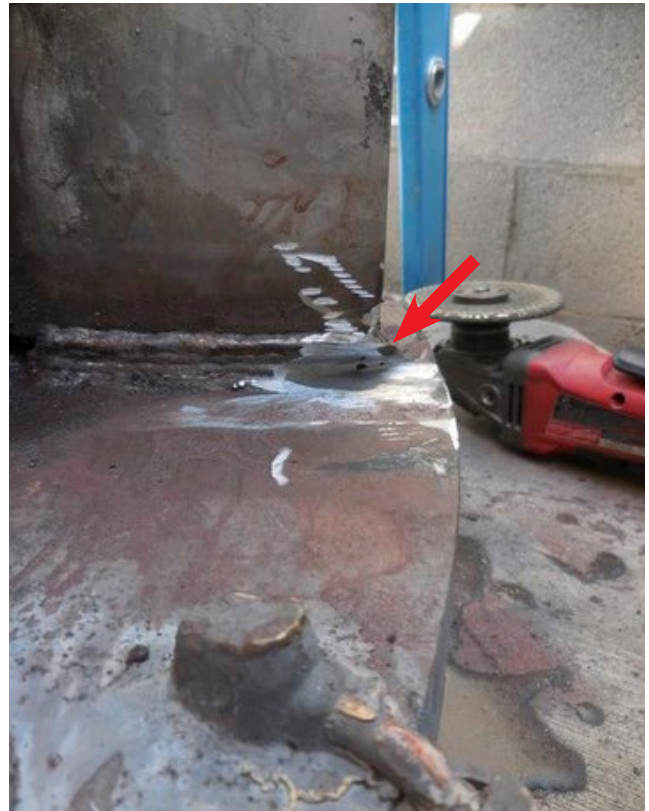
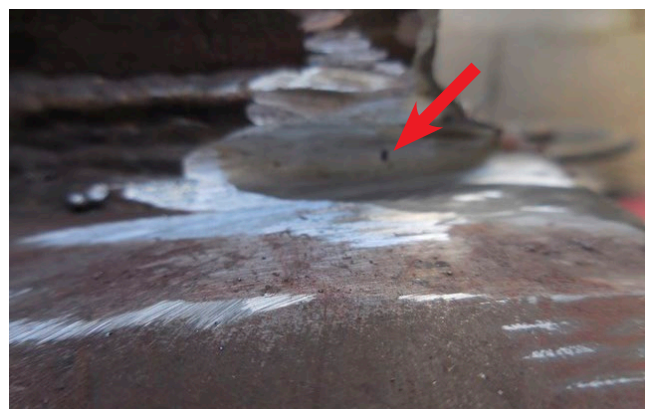
Inclusion is defined as entrapped foreign solid material, such as slag, flux, tungsten, or oxide. When it comes to tower and monopole upgrades, typically inclusion is slag left within a complete joint penetration (CJP) weld and is located by a post-modification ultrasonic testing (UT) non-destructive examination. Slag inclusions result from improper welding technique, lack of access, or improper cleaning between weld passes.

Monopole Base Plate Stiffener Weld CJP Connection Slag Inclusion

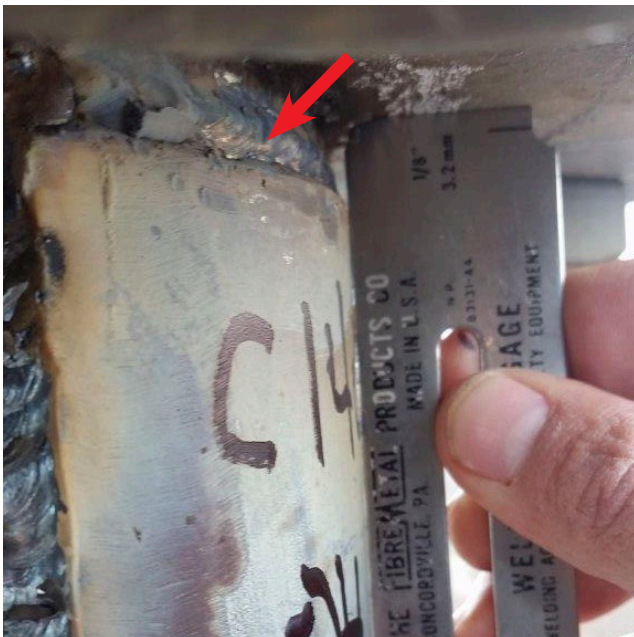
Incomplete joint penetration is a joint root condition in which the weld metal does not extend through the joint thickness. In other words, the weld does not penetrate into the root area of the weld. Typically, this condition is identified via UT non-destructive weld examination.

Tower Leg Split Pipe Modification Incomplete Joint Penetration to Leg Flange

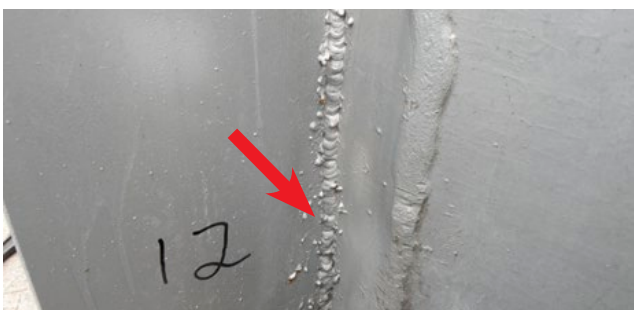
Weld Spatter at a Modification Stiffener and Field-Welded Port Installation

Spatter is the metal particles expelled during welding that do not form part of the weld. Spatter is easily repaired with a grinder.

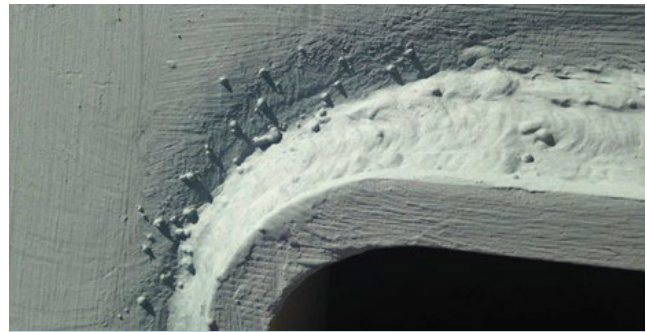
Weld Spatter at a Modification Stiffener and Field-Welded Port Installation

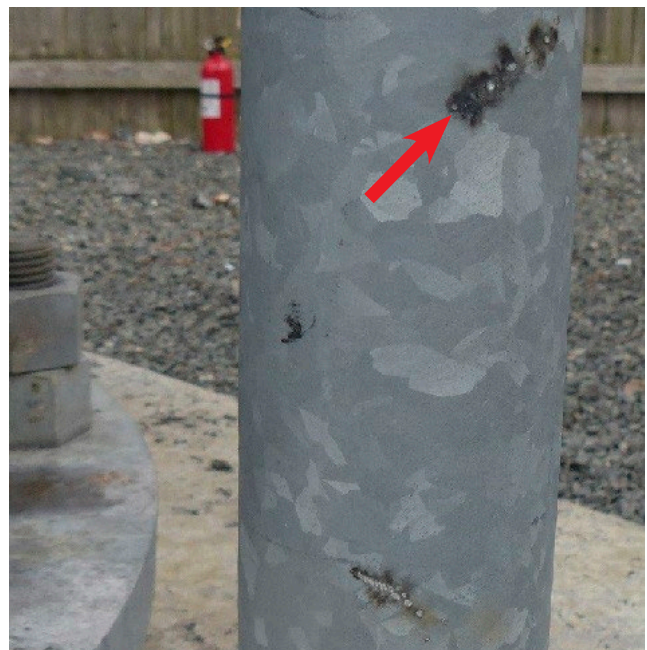
An **arc strike** is a discontinuity resulting from an arc, consisting of any localized re-melted metal, heat-affected metal, or change in the surface profile of any metal object. Arc strikes result when the welder initiates an arc on the base-metal surface away from the weld joint, either intentionally or accidentally. When arc strikes occur there is a localized area of the base metal surface that is melted and then rapidly cooled due to the massive heat sink created by the surrounding base metal. Arc strikes are not desirable as they can cause cracking.

Arc Strikes on Ice Bridge Post

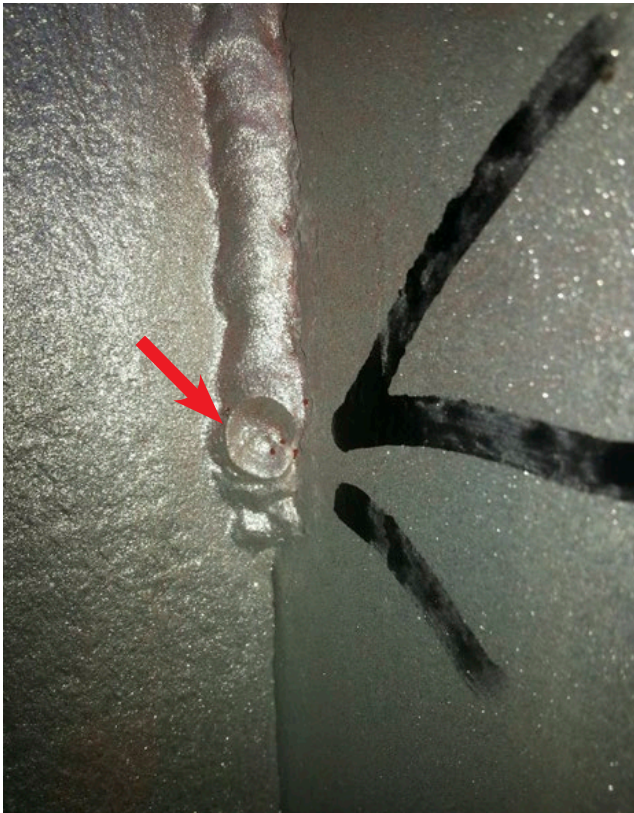
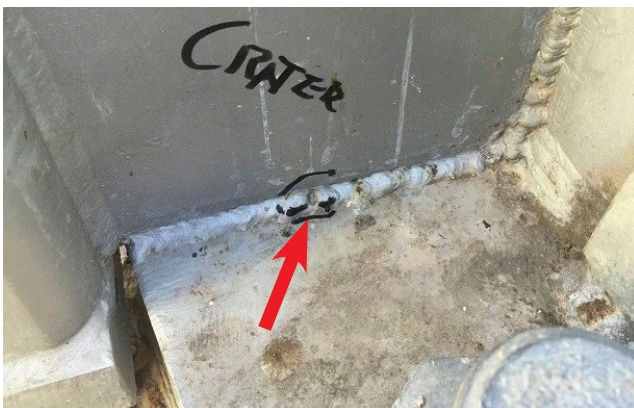
A **crater** is a depression in the weld face at the termination of a weld bead. AWS D1.1, Table 6.1 requires all craters to be filled to provide the specified weld size, except for the ends of intermittent fillet welds outside of their effective length.

Crater Defects

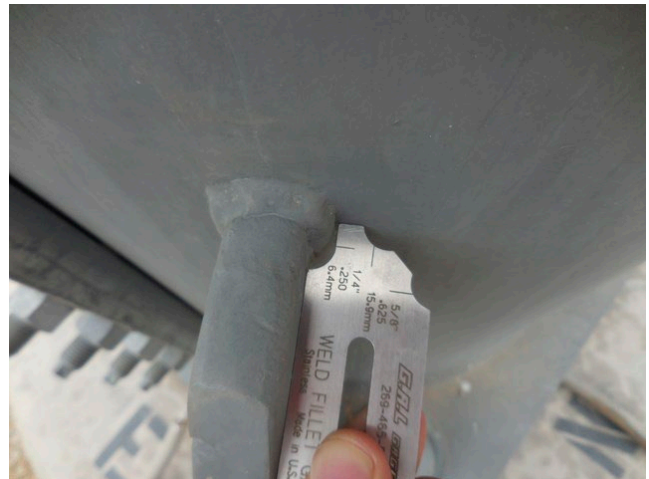
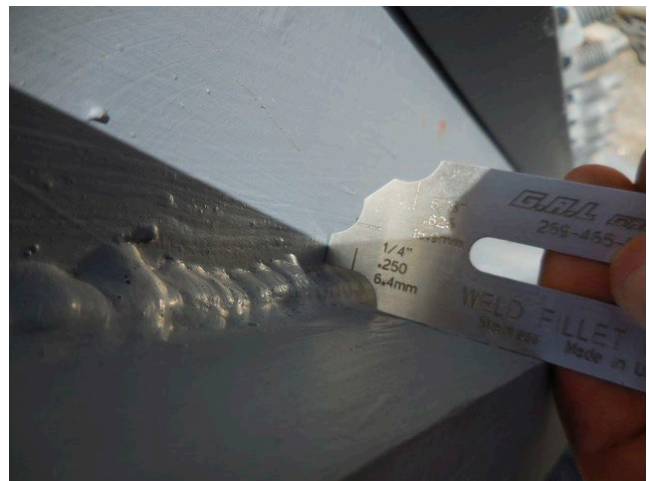
An **undersized** weld does not meet the size requirements of the project specifications. This defect is commonly seen in the field and is easily avoided. A welder should be checking the sizes of their welds after completion. Fillet welds are measured by CWI's with fillet weld gauges.

Required Stiffener/Plate Modification 1/4" Fillet Welds Undersized by Fillet Weld Gauge Measurement
