# Monopole Base Weld Toe Cracks and Why They May Collapse Your Tower

By Brian R. Reese, P.E., CWI, and David W. Hawkins, P.E.

Crack identification and a proposed severity classification system hold promise for helping owners maintain their towers in the face of aging and wear that can lead to cracks that threaten structural integrity.

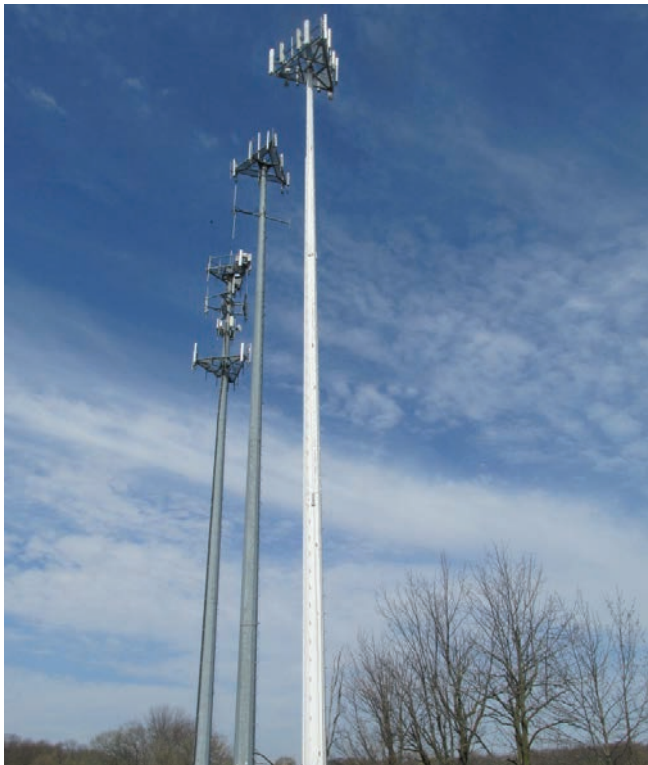
**Figure 1.** Tubular steel monopoles are popular support structures in many industries. They have seen use as support structures in the communications, sports lighting, utility and transportation industries for many decades.
